# **Buncefield Incident – Some Lessons Learnt**

# Dr Fathi Tarada

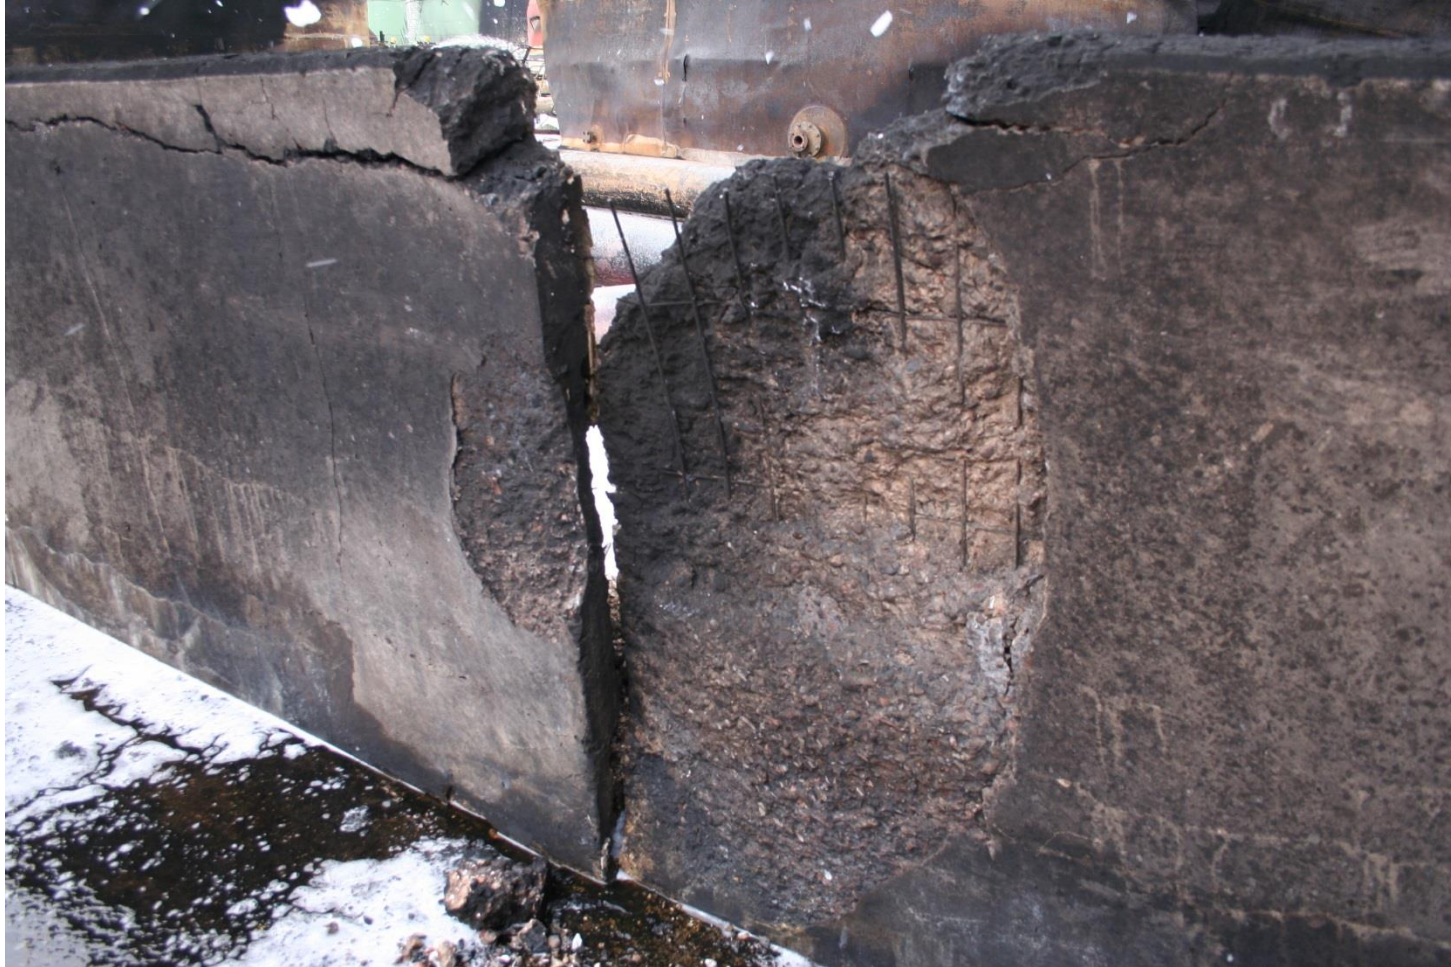
# No Reinforcement Steel through Joints

- Standards not adhered to
- Waterstops missing
- No reinforcement steel through joints
- Obtuse angles between bund sides
- Shielding of joints would have assisted in protecting them

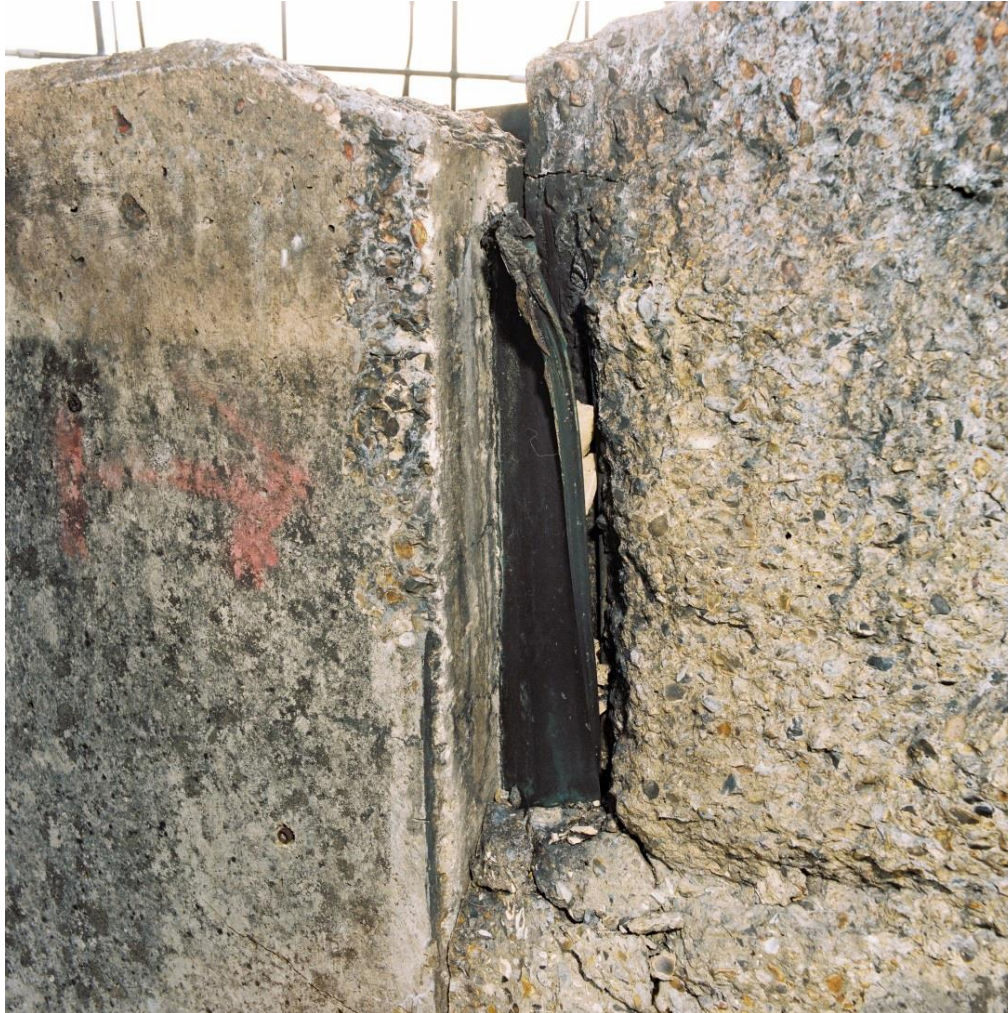
# Failed Rubber Gasket

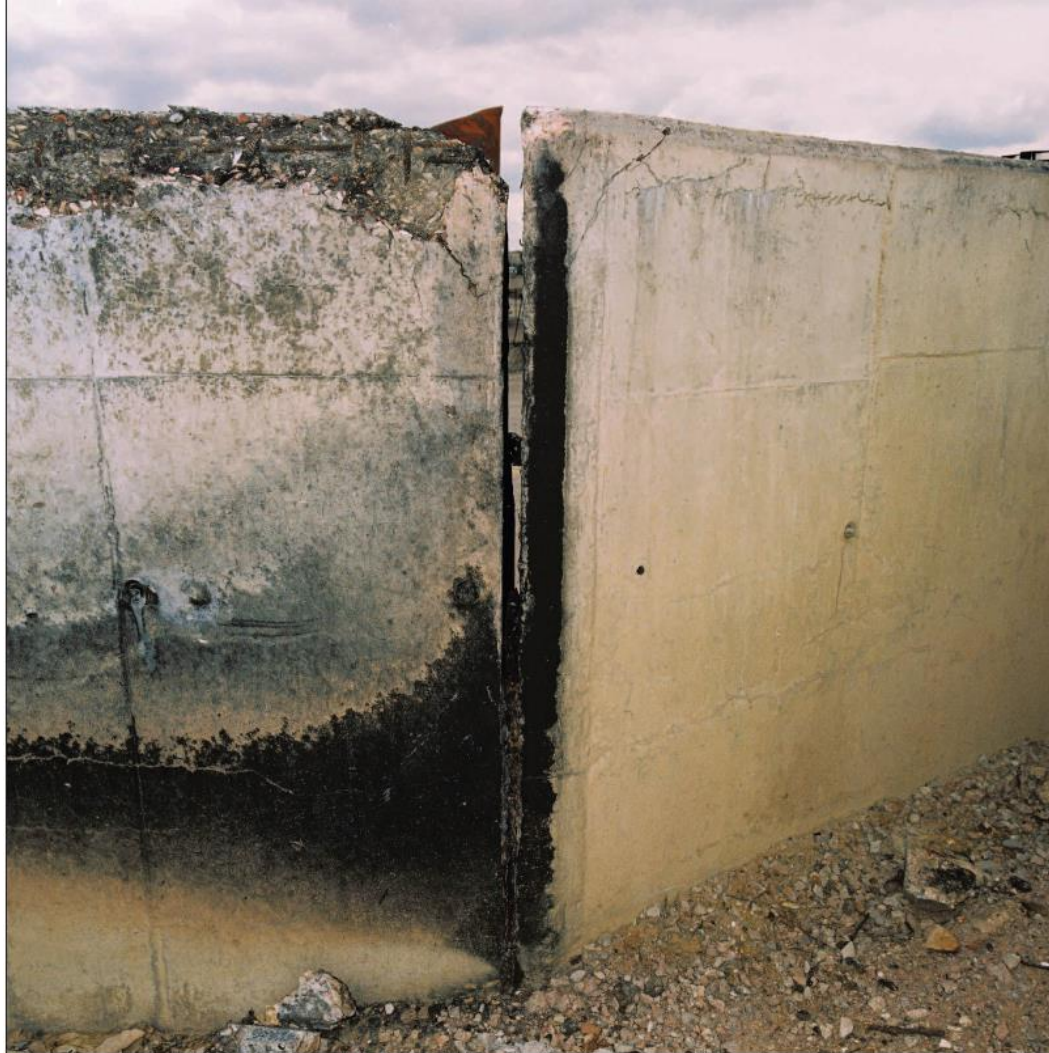
# Obtuse Bund Angles

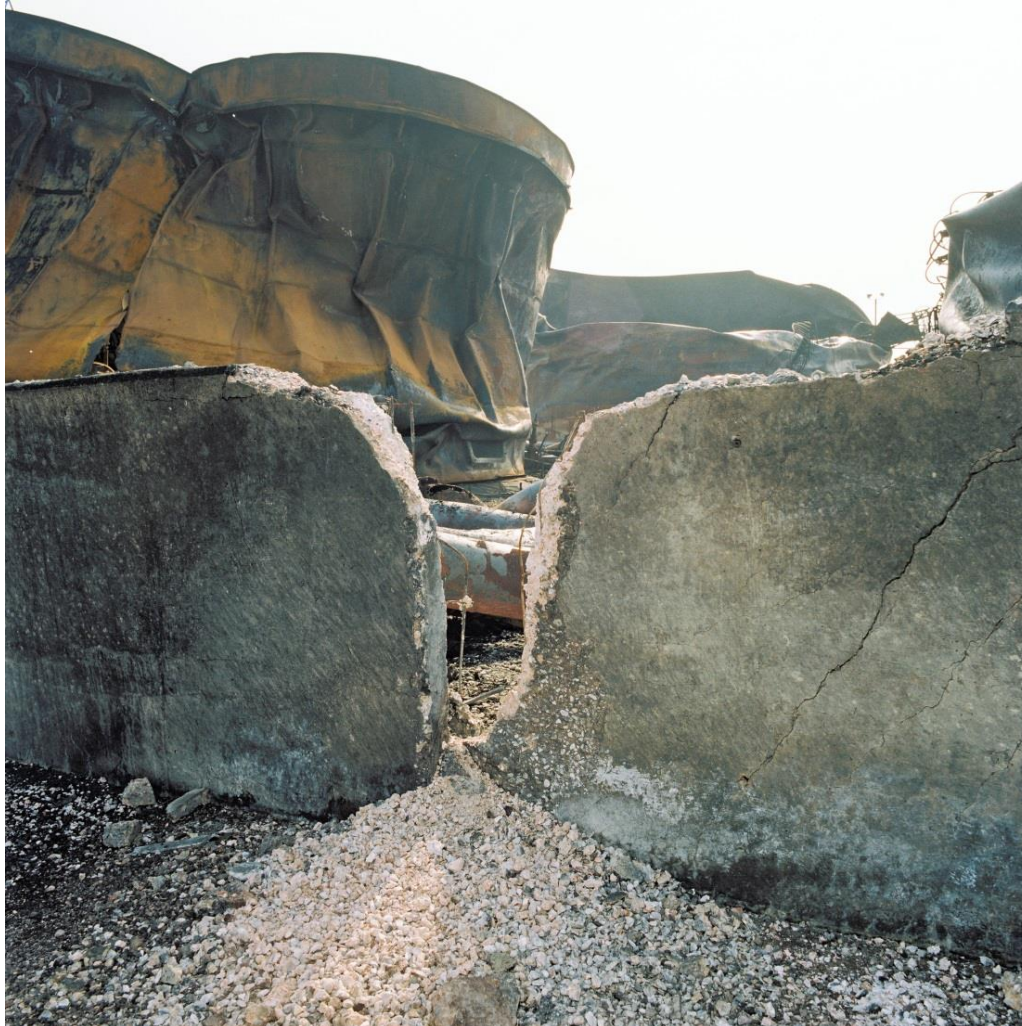
# Spalled Bund Joint

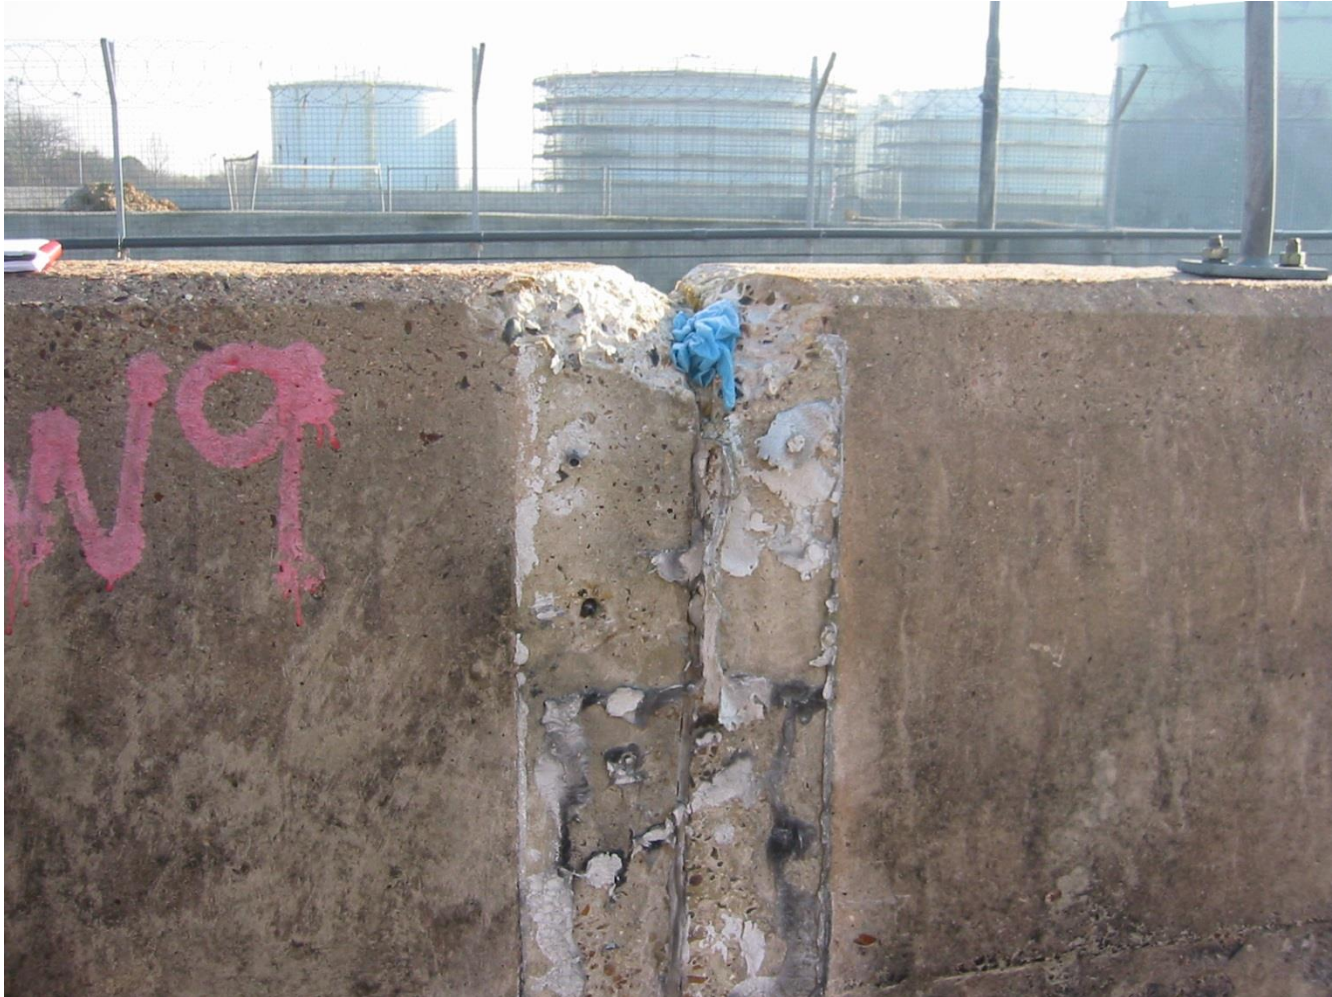
# Shielding Effect of Steel Plate

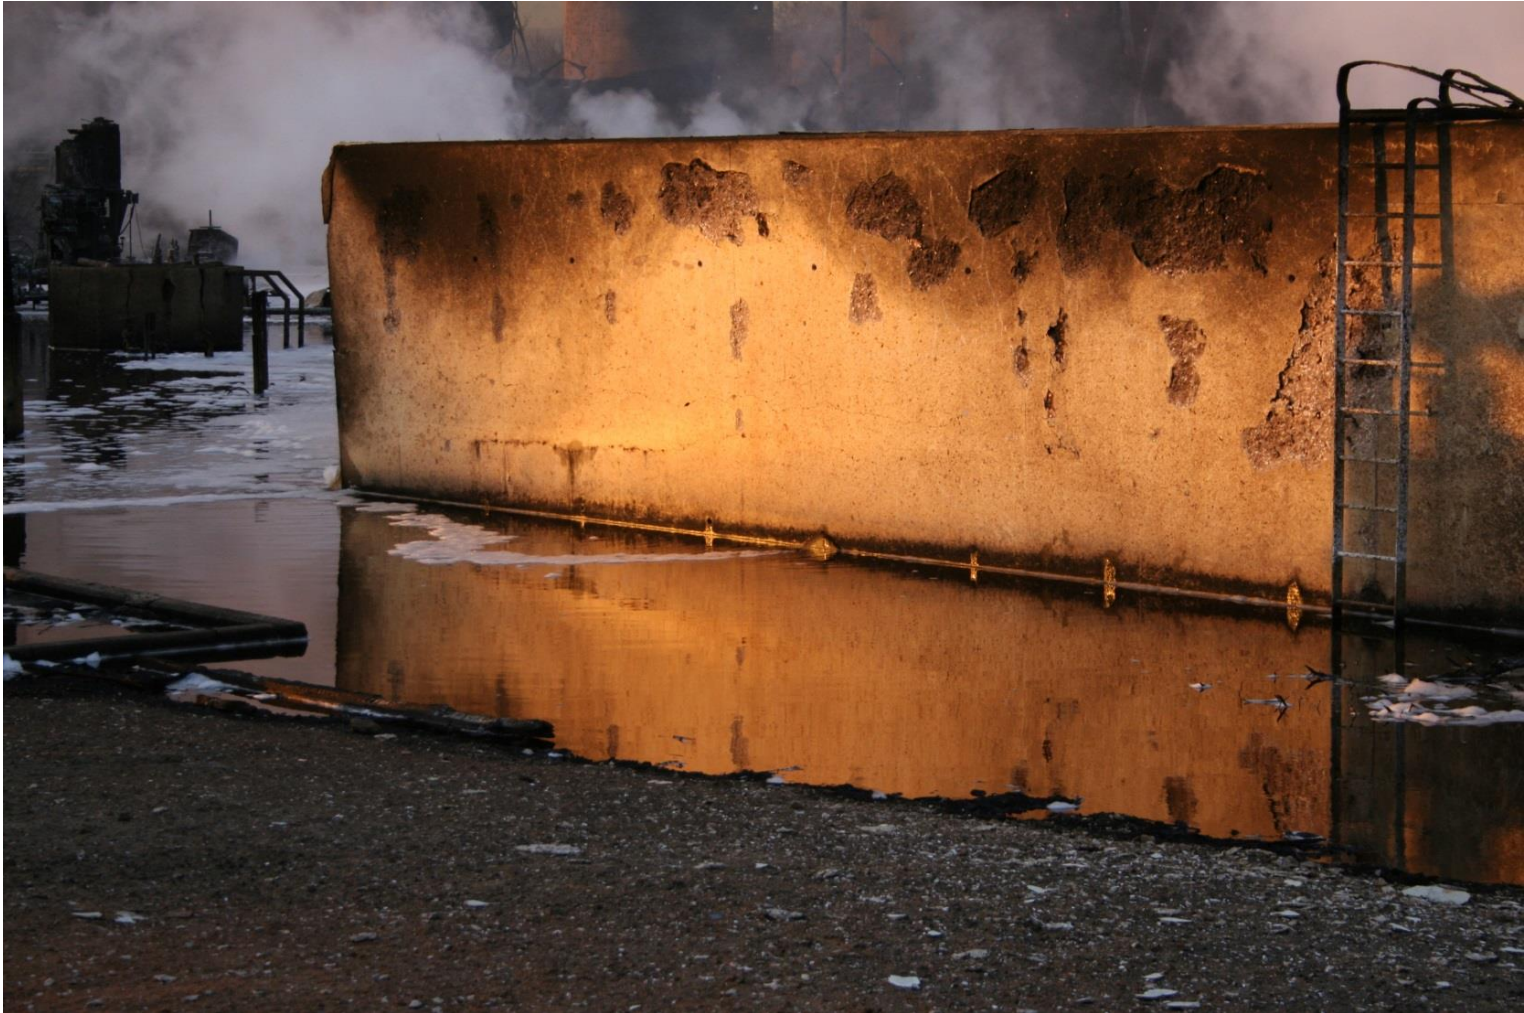
# Tie Bar Holes

- Loss of secondary containment:
  - Bund joints
  - Tie bar holes
  - Pipe penetrations
- Tertiary containment

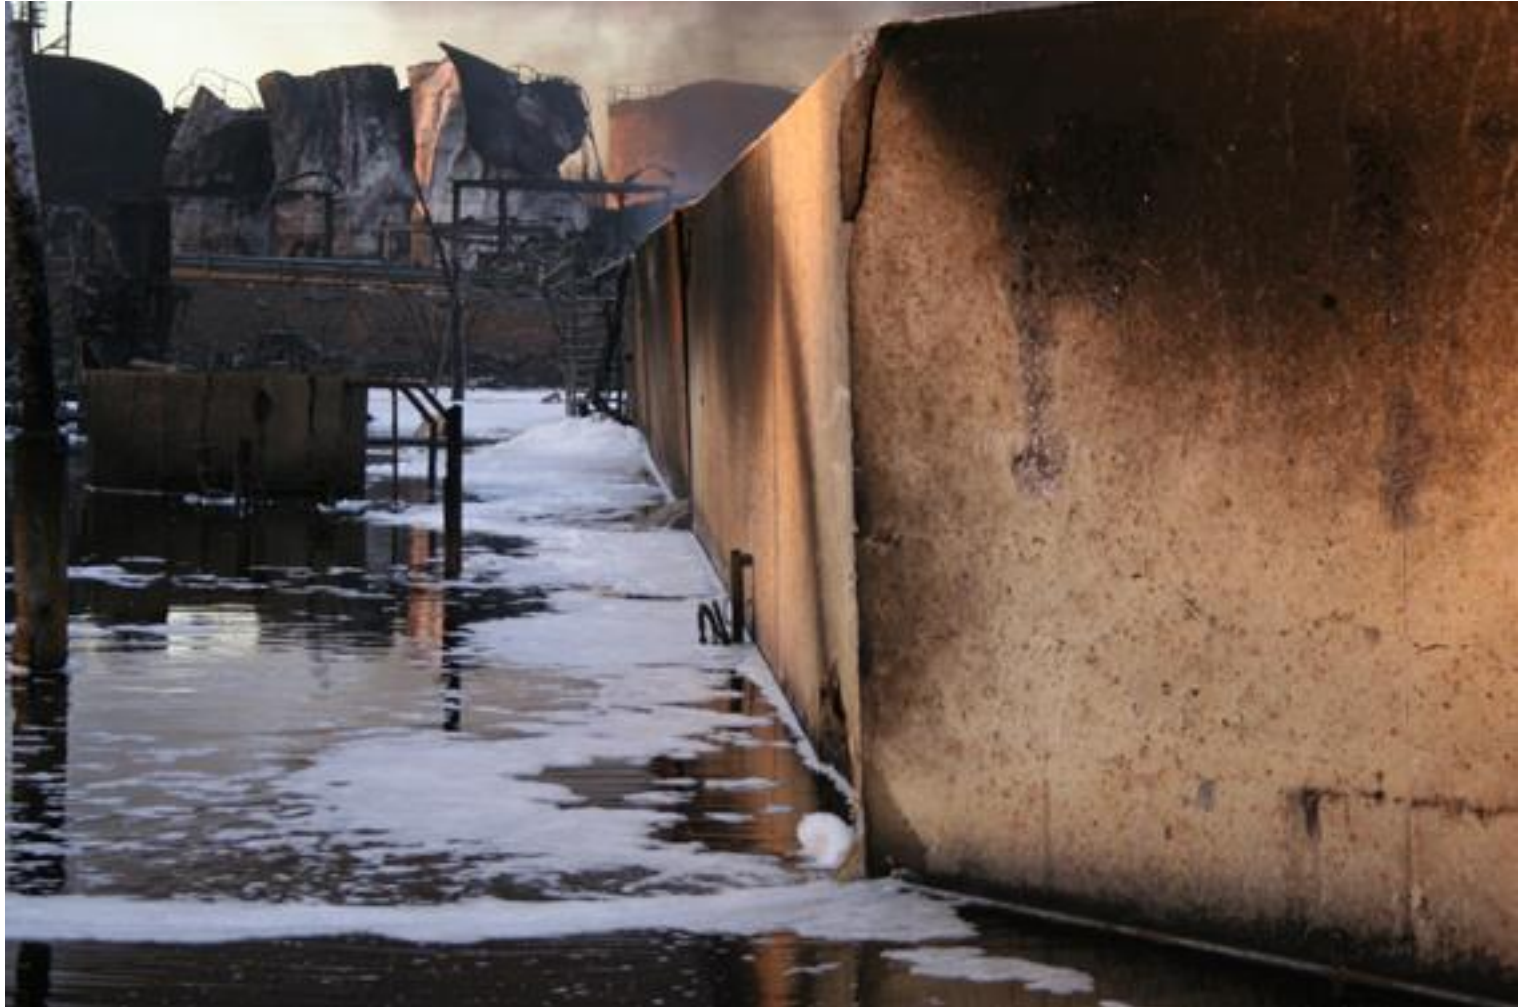
# Escape of Product & Firewater

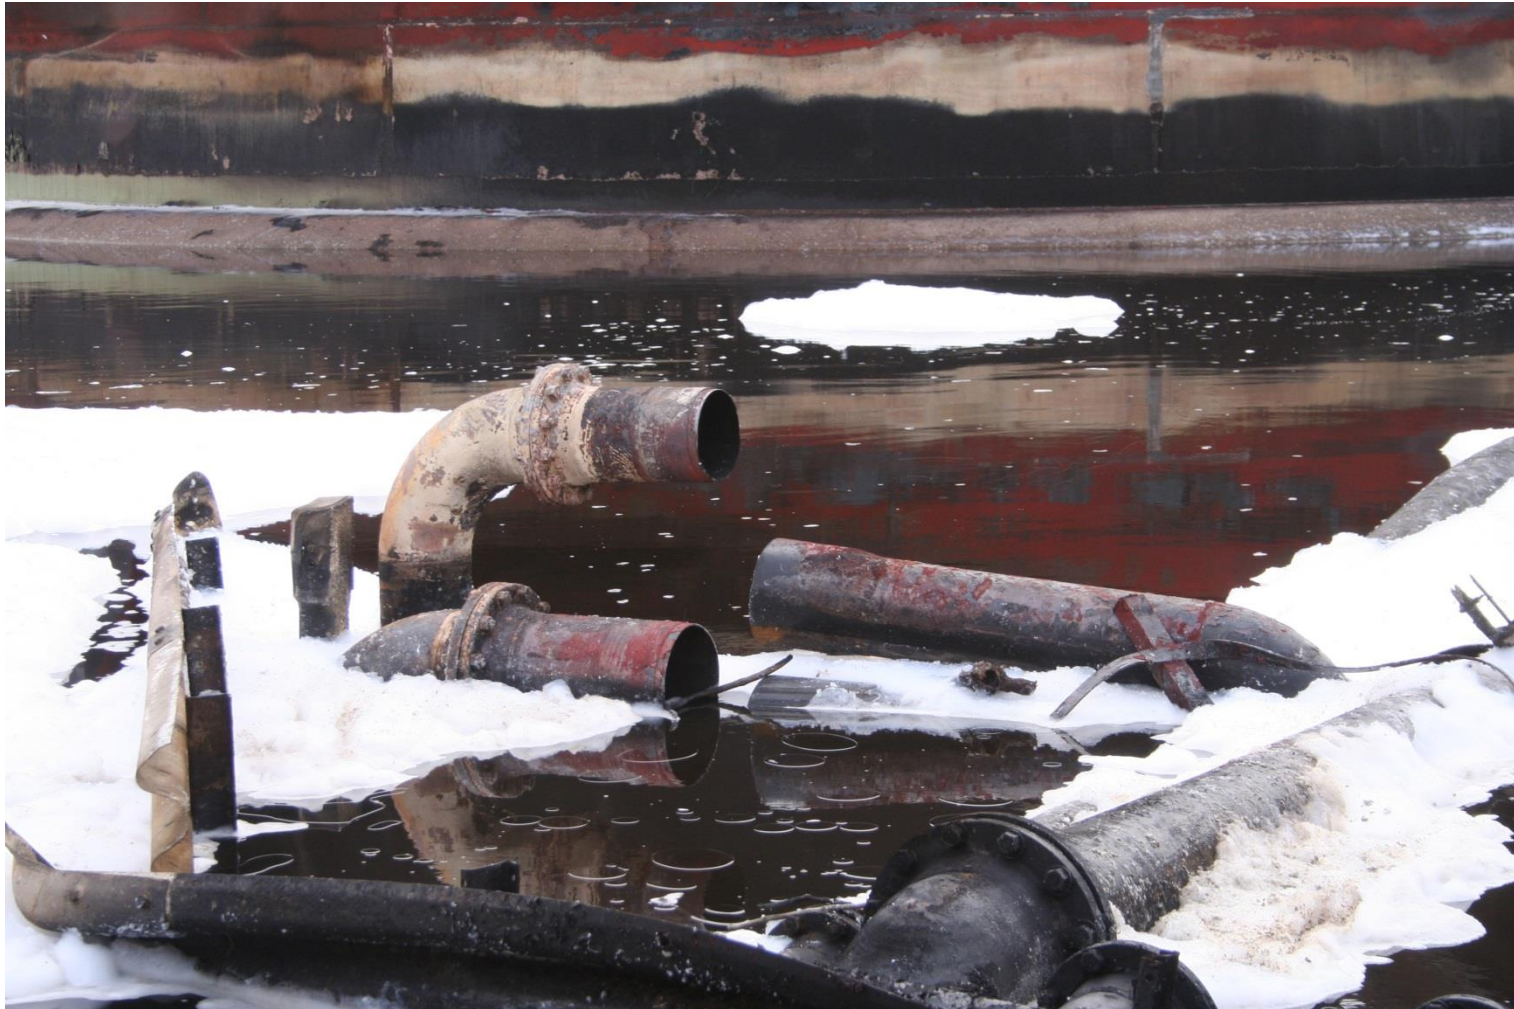
# Destroyed Pipework

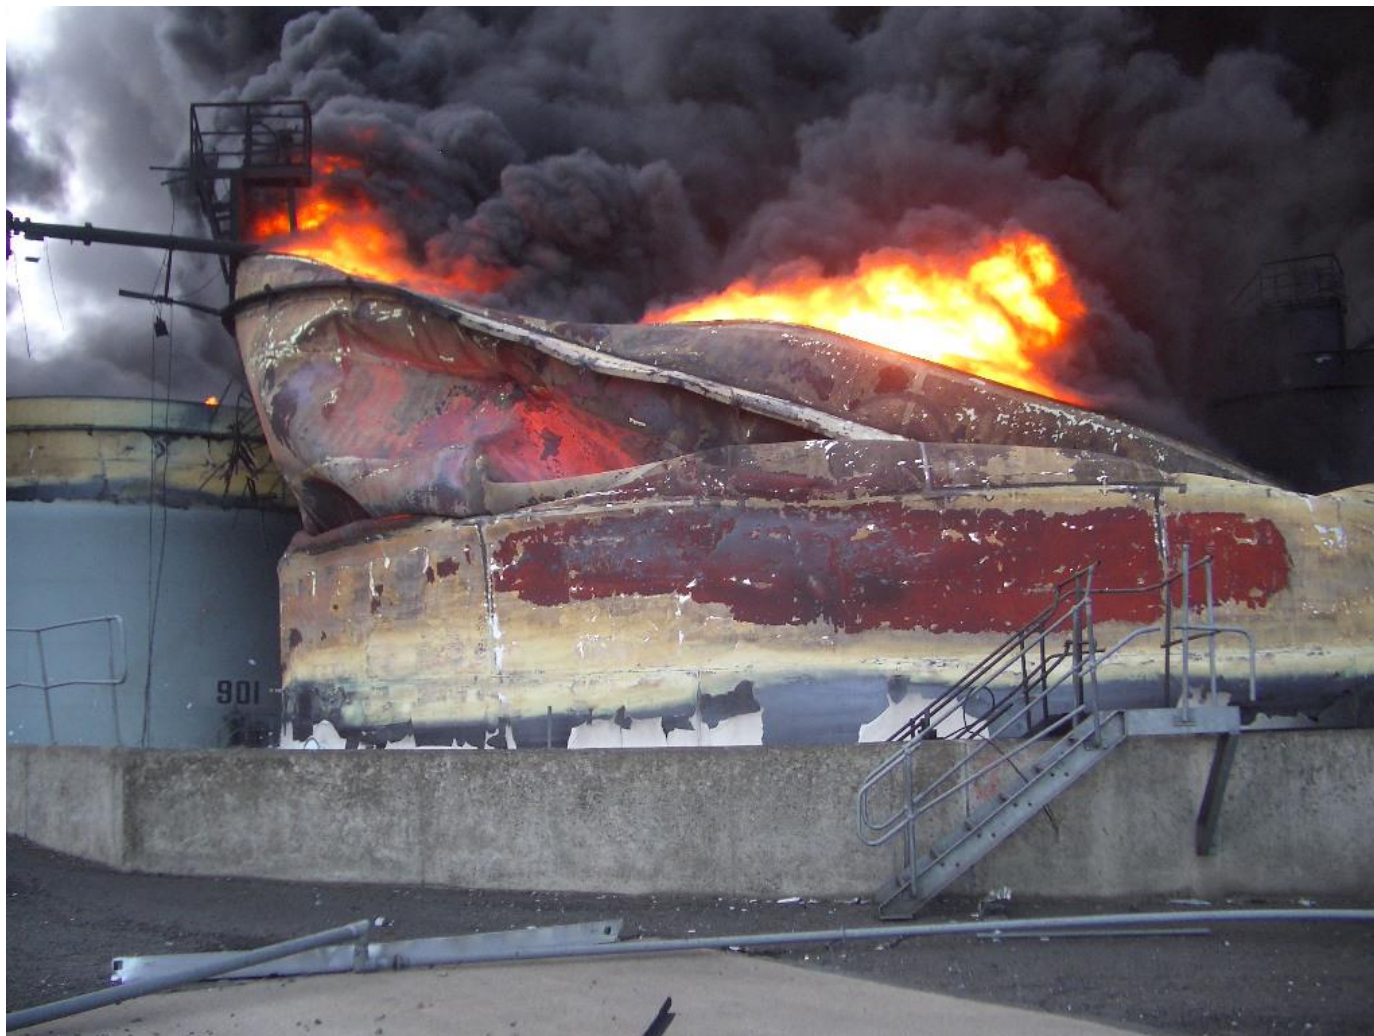
# Tank Collapse

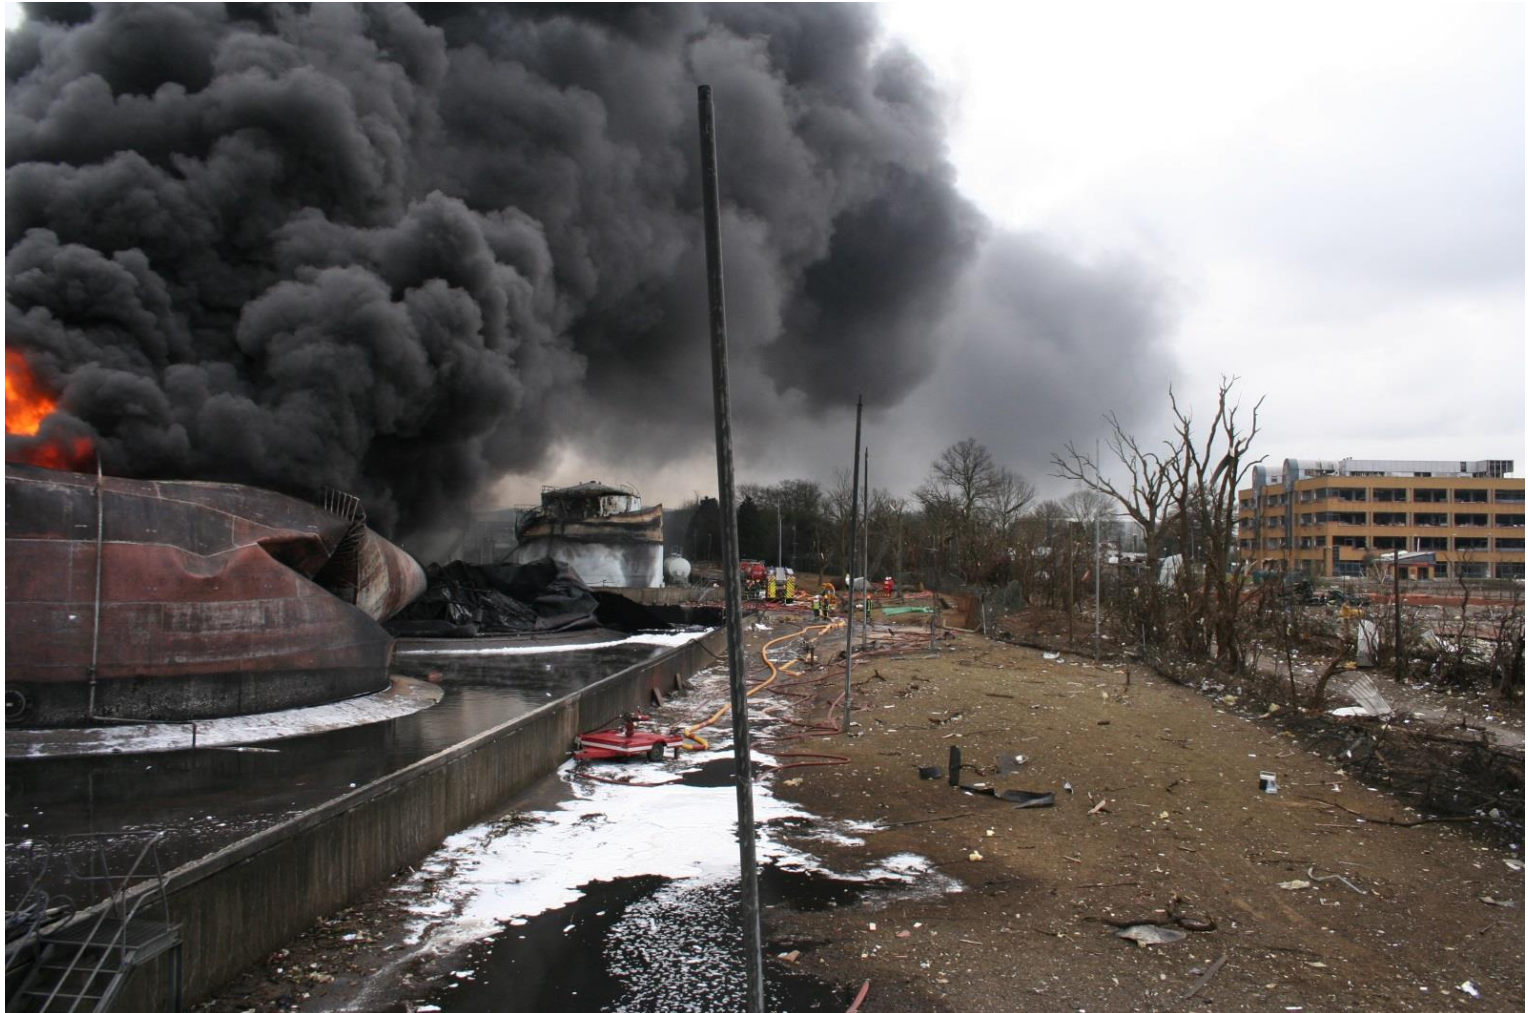
# Escape of Fire-Fighting Water & Foam

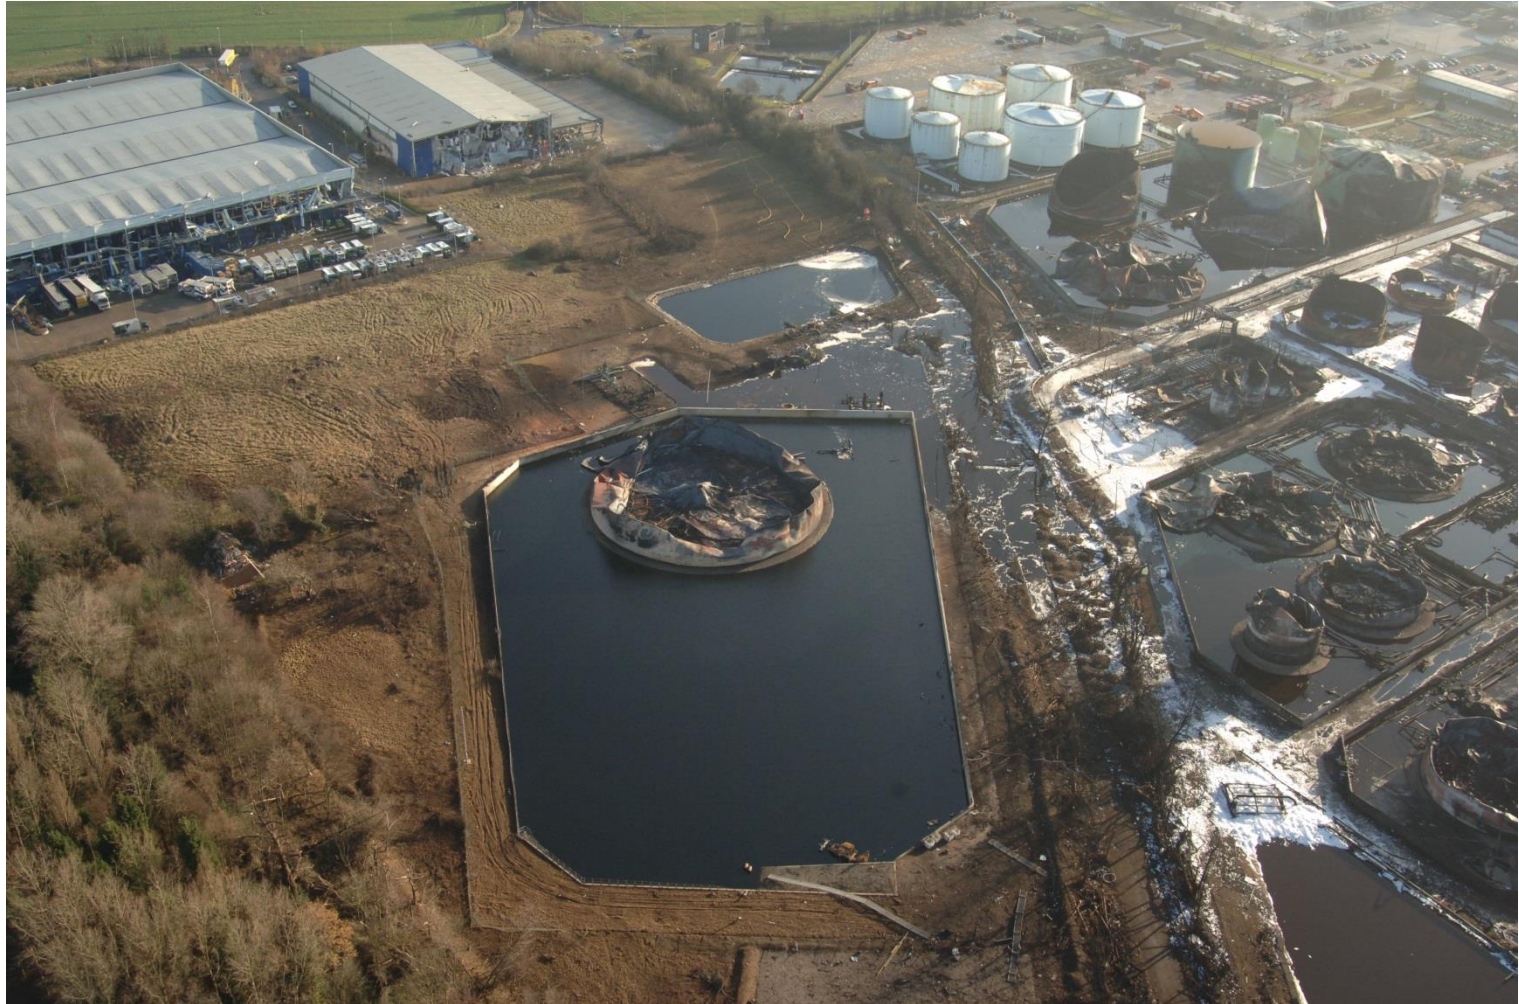
# Escape of Product and Firewater

- Drainage system had limited capacity, and led to soakaways.
- The fire water lagoon had an intrinsic flaw in that it flooded the fire pump house when it was full.
- The site topography was not suitable for retention of petroleum products on site, since any flow would naturally go down Cherry Tree Lane.

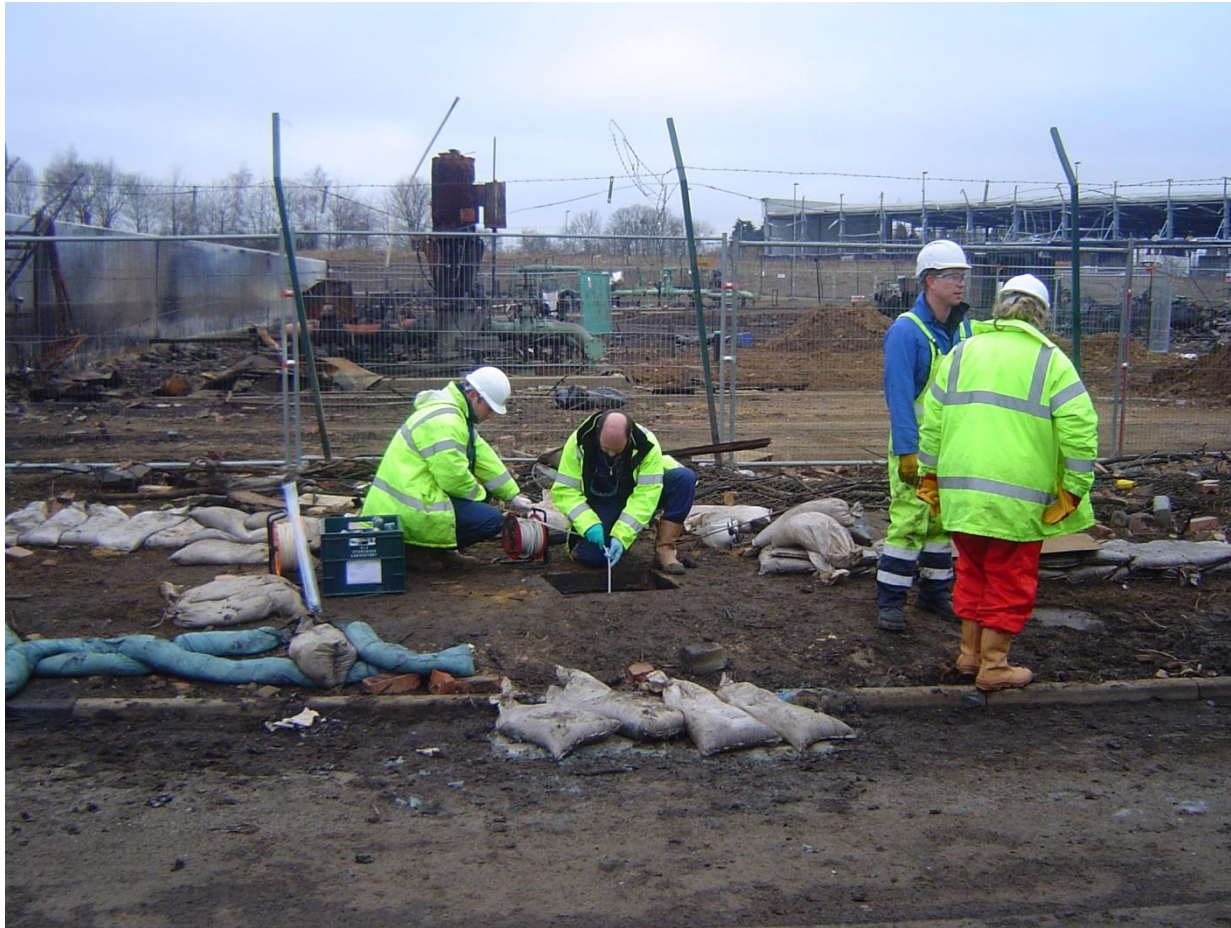
# Contamination of Drainage System

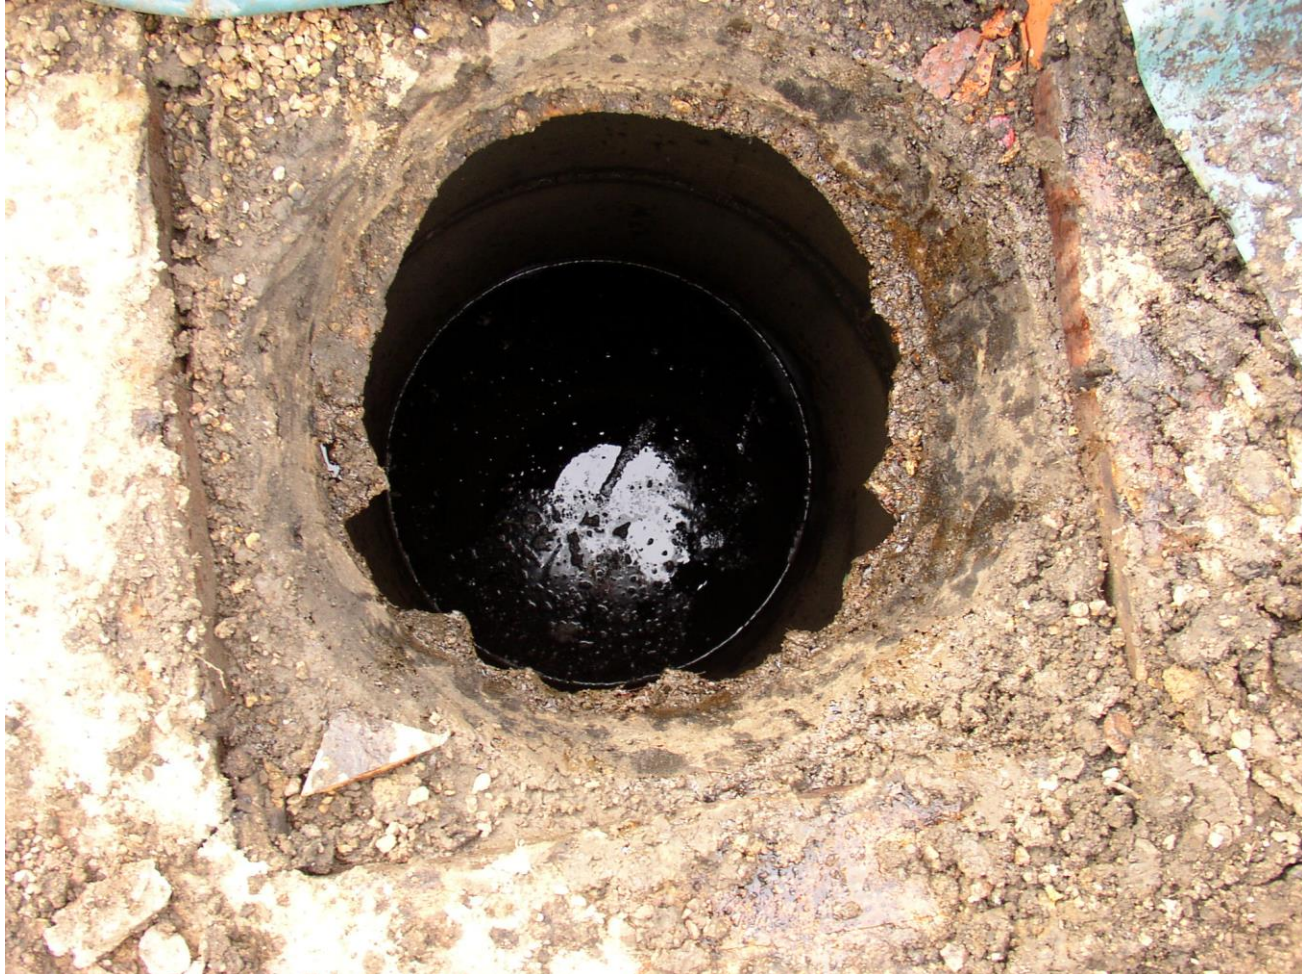
# Contamination
