# Containment for petroleum products – lessons learnt from Buncefield, UK

**1 Fathi Tarada** BSc, DPhil, MBA, CEng, FIMechE, FIFireE, DipLLaw  
Managing Director, Mosen Ltd, Forest Row, UK

**2 Peter Robery** FEng, FICE, FCS, MICT  
Technology Director, International Transportation, CH2M HILL,  
Birmingham, UK

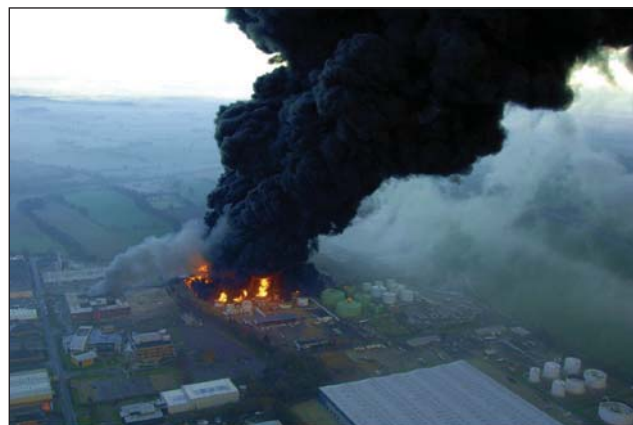
the explosion, the fire then destroyed most of the site and generated large clouds of black smoke, which dispersed over southern England and beyond as the fire raged for 5 days. The Hertfordshire Fire and Rescue Service attended the incident and had enormous difficulty tackling the fires, which has been well documented. Escape of fuels, water and foam from the bunds was a significant added complication for the fire and rescue service, as was the realisation that emergency plans to use some bunds as remote secondary containment did not work as the bunds had become damaged by heat from the fire.

Figure 1. Buncefield plant on fire on 11 December 2005 (courtesy Royal Chiltern Air Support Unit, <http://www.buncefieldinvestigation.gov.uk/images/gallery/casu02big.jpg>)

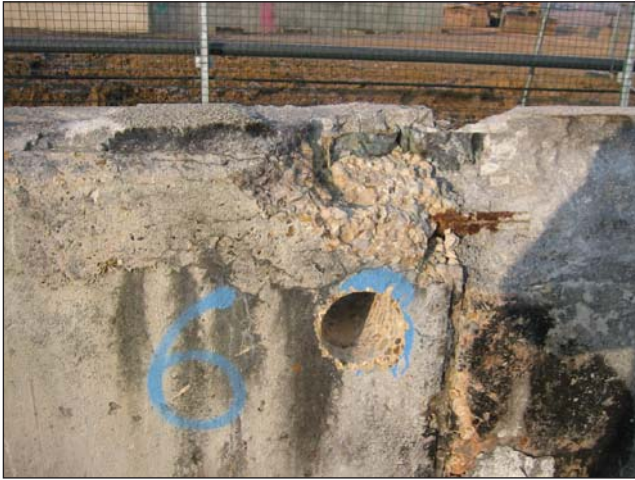
The main bund was built in the 1960s and had concrete walls and an earth base. A corrugated copper sheet water stop was provided across each joint in the centre of the wall, which was a standard waterproofing detail of the time. These sheets functioned well – even though this bund was exposed to a bund pool fire and tank fires, the joints performed well and did not leak significantly (see CA, 2011).

Figure 4 shows the location of core 6 in the western main bund wall, in the vicinity of a joint. The copper sheet is partially visible in the upper part of the picture. Although this joint showed extensive spalling, it performed well in retaining liquids during the fire. The concrete repairs to the wall also performed well and showed no signs of significant delamination.

Figure 4. Main bund joint (with core sample 6 cut through it)

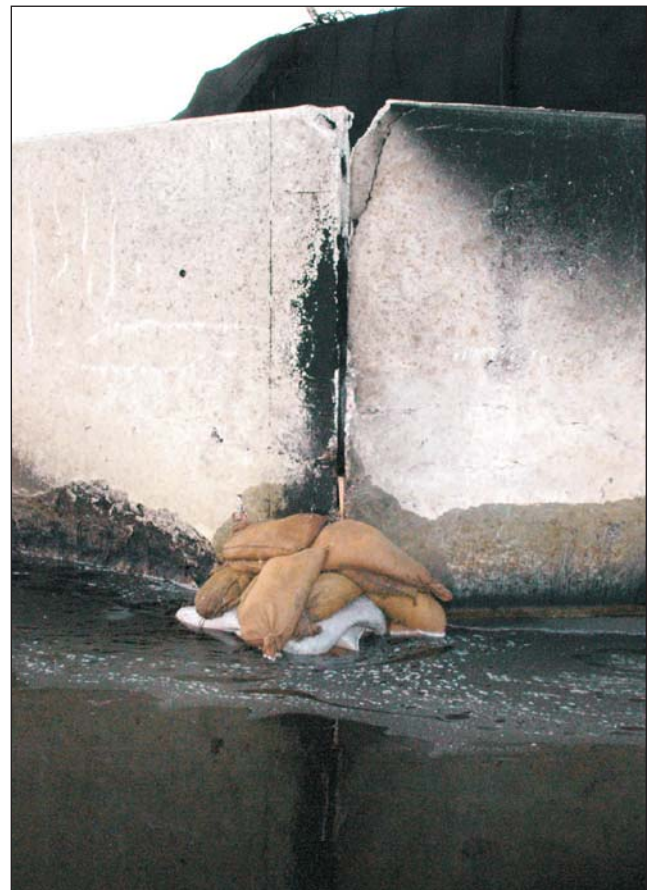
The bund walls were built with simple vertical butt joints, formed by casting against a compressible filler material between the sections, with sealant material gunned into the visible top and sides of the joint. Some joints were positioned at corners, at either obtuse 30° or 90° corners. The base slabs similarly did not have any water stops provided at either movement joints or tied joints.

As a consequence of the lack of dowels and water stops, the joints in the tank 12 bund walls leaked extensively during the incident, with the shallow angles forcing the walls out of plane when heated by the burning fuels

The only waterproofing was a mastic sealant poured into a groove formed by casting the concrete against a compressible filler material. This single bead of sealant was the only measure preventing escape of liquids from the bund. At tied joints, where the reinforcing fabric reinforcement ran continuously across the joint, joint sealant did not appear to be provided. This construction did not conform to any recognised standard for the containment of water or fuel within bunds. BS 8110 (BSI, 1985) and BS 8007 (BSI, 1987a) indicate that dowels and water stops are required at movement joints to prevent out-of-plane movement and leakage at these locations. As a consequence of the lack of dowels and water stops, these joints leaked extensively during the incident (Figure 5), with the shallow angles forcing the walls out of plane when heated by the burning fuels. This allowed fuel, foam and firewater to leak out of the bund.

Figure 5. Obtuse angle butt joints at tank 12

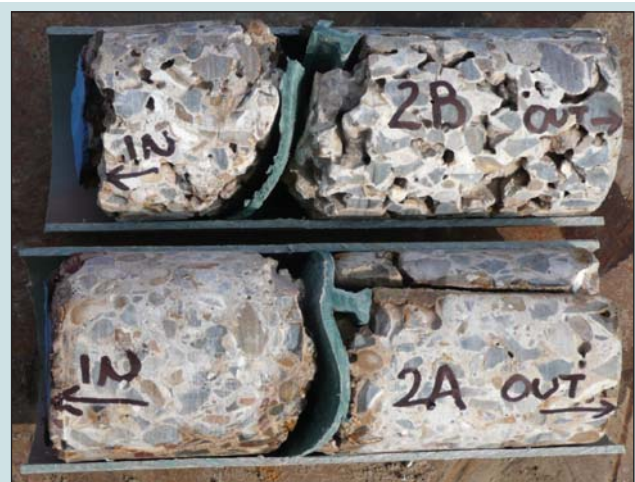
Core 2B: taken through the wall of bund E, showing very little heating damage to the concrete and no evidence of damage to the polyvinyl chloride water stop.

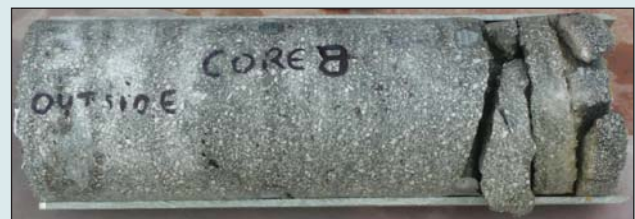
Core 8: taken through a repaired area of main bund showing laminar striations in the outer 50 mm of the wall, but generally very good performance for the sprayed concrete material.

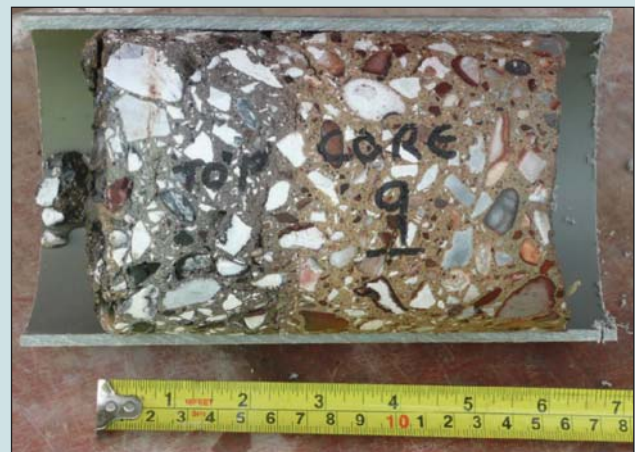
Core 9: taken from the floor to tank 12 bund under an area suspected of receiving a jet of burning fuel. 70 mm thick light grey zone exhibits extreme heating.

have been under a jet of escaping fuel. The petrographic examination revealed the concrete had been heated to very high temperatures and for a considerable depth. Nearly the full thickness (130 mm) of the 150 mm slab had been heated to above 600°C; the full depth was weakened by the fire effects and the outer 18 mm reached temperatures above 900°C.

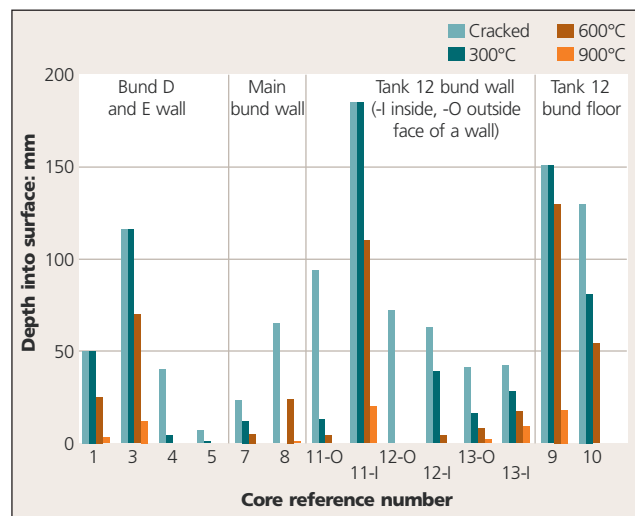
Figure 6 shows that, based on the samples taken from the walls of bunds D and E and the tank 12 bund, the concrete had generally performed well in the fire in terms of resistance to heat. Generally, the heat-affected zone (>300°C) was less than 60 mm, with two notable exceptions: in core 3 (bund D/E) and core 11 (tank 12) the 300°C depth (dark blue bars) was 118 mm and 182 mm respectively, with the depth of substantial structural weakening (>600°C) at 70 mm and 110 mm respectively (brown bars). Given that PVC will melt at temperatures of around 200°C and the walls are typically 300 mm in thickness, this evidence suggests it is marginal whether PVC would have been exposed to temperatures sufficient to melt it during the most severe exposure to heat from this fire in the tank 12 bund, had it been used as a water stop.

Figure 6. Heat-affected depths into the concrete bund surfaces

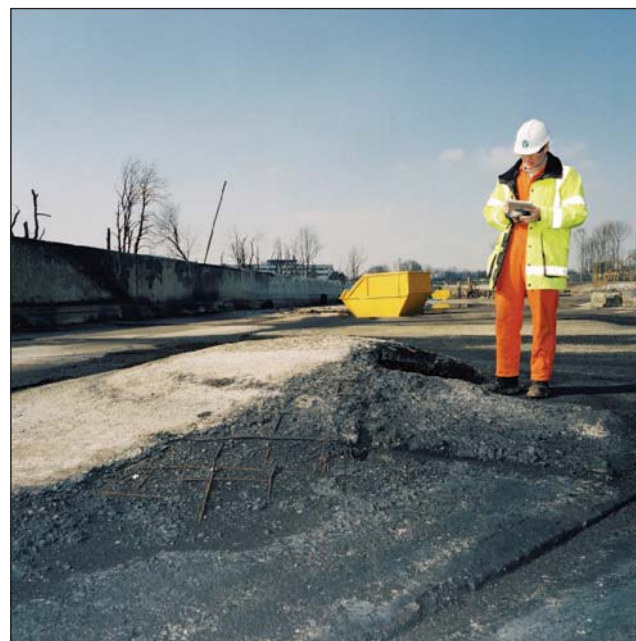
Concrete comprising the base slab of the tank 12 bund generally appeared to be unaffected by the fire, with escaping fuel and then firewater protecting the concrete from direct heat exposure. However, one location had substantial darkening and lifting near to tank 12 itself. Cores 9 and 10 were taken from this bay of concrete (bay M in the tank 12 bund), an area which may

The lifting of the slab in bay M was probably the result of

Figure 7. Fire-damaged reinforced concrete floor at tank 12 bund

expansion in the flint gravel coarse aggregate in the upper part of the floor slab, which undergoes a phase change at 573°C accompanied by 5% increase in volume (The Concrete Society, 2008). This expansion would create stresses in the outer fibres of the concrete and cause the area to curl and lift. An example of the damage observed to the bund floor is given in Figure 7.

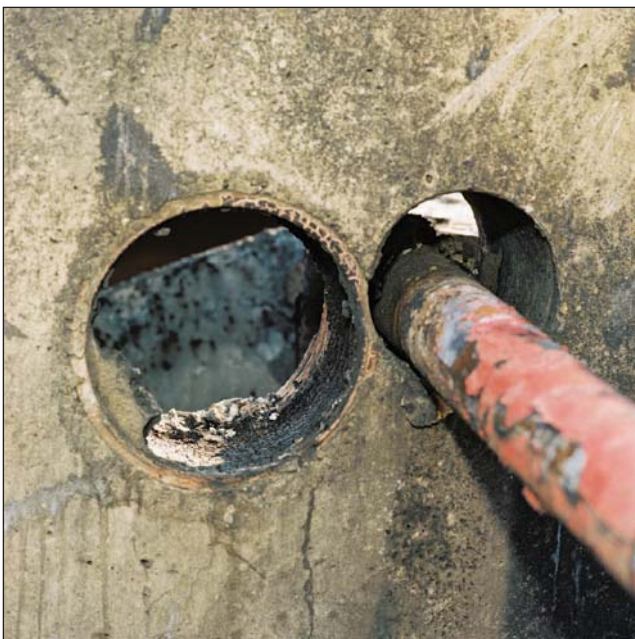
Some penetrations appeared to be retrofitted, with the top of the wall cut back, the pipes installed into over-sized holes and the concrete reinstated, whereas others were original installations. Generally, the pipe penetrations were not sealed into the wall with puddle flanges, as would be normal for a water-retaining structure, and failed in several different ways.

For walls, some pipe penetrations were in over-sized holes and provided with a flexible ‘bellows’ arrangement that was intended to provide a liquid-proof seal between the pipe and bund wall, so allowing differential thermal movement between the concrete wall and the steel pipe. Unfortunately, the flexible bellows were not adequately fire resistant and were consumed by the fire, leaving a substantial gap through which fuels floating on firewater could escape (Figure 8). In addition to being damaged by fire, it is possible that the bellows could also have been damaged by the vapour cloud explosion.

In cases where the pipes were a closer fit, passing through walls and floors, only sealant had been provided to prevent leakage, which proved not to be resistant to fire. Where pipe penetrations had been retrofitted, thermal movement of the pipe

Figure 8. Bund pipe penetrations (lacking puddle flanges)

or heating of the concrete led to failure of the wall around the pipe penetrations, most probably because the re-cast concrete used to close the opening in the wall was not tied in by properly anchored reinforcement.

The best precaution with regards to service penetrations through bund walls is to avoid them whenever possible, and to route the services over the bund walls. If pipe penetrations are deemed essential, it is industry practice, as indicated for example by section 3.4.4 of BS 8000-15:1990 (BSI, 1990) and section 16 of BS 8005-2:1987 (BSI, 1987b), that puddle flanges should be provided to ensure an adequate seal around pipe penetrations through concrete structures, as recommended post-Buncefield (BSTG, 2007).

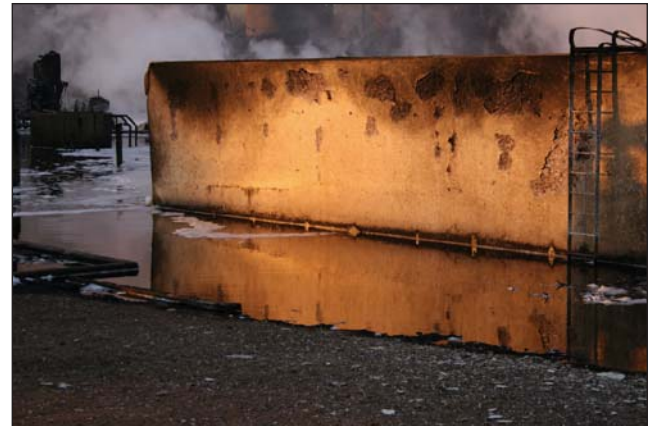
Figure 9. Leaking tie-bar holes in tank 12 bund (at lower part of bund)

A significant amount of leakage was observed from tie-bolt holes within the British Pipeline Agency tank 12 bund (Figure 9), which added to ‘Lake Buncefield’. Tie bolts had been used to secure the formwork together at low level, so gripping the kicker formed off the perimeter beam. This is normal practice to establish a good seal against the kicker concrete, where the bolts pull the two sides together. However, the method used was not appropriate for a water-retaining structure, because the bolts comprised debonded lengths of threaded steel in a plastic sleeve that were pulled out and re-used.

mortar, giving the appearance of a sealed hole that proved not to be resistant to heat from the fire. There were some indications prior to the incident that the tie-bolt holes were weeping rain-water, but no actions had been taken to investigate or address the leakage before the incident occurred.

Commonly available on the market are leave-in tie-bolt fittings that are cast into the concrete. The tie bolt is then removed from each side, with the fitting blocking the passage of water through the wall. Alternatively, special rigs can be used that do not need low-level tie bolts: Figure 10 (redrawn after Ciria report 164 (Mason *et al.*, 1997)) shows a shuttering arrangement for a reinforced-concrete bund wall, with formwork panels supported by props or braces. Such formwork would have avoided tie bolt holes altogether.

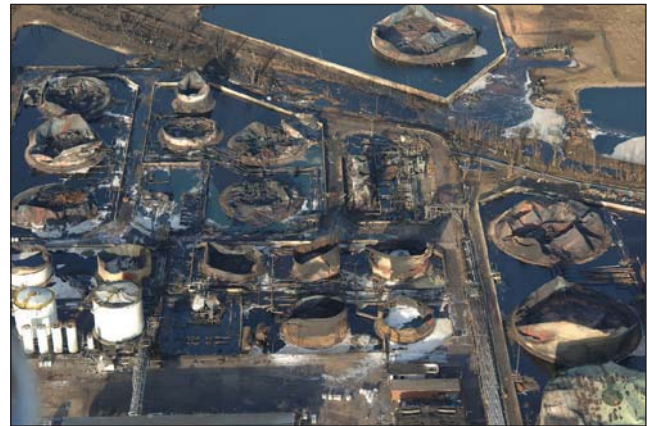
However, there was large and uncontrolled release of product and firewater into the environment during the incident, due to inadequate site profiling and drainage arrangements (Figure 11).

Figure 11. Escape of product and firewater from Buncefield bunds

The topography of the site encouraged liquid run-off to the north of the Hertfordshire Oil Storage West site, down Cherry Tree Lane and beyond, past the roundabout into Hogg End Lane and as far as the M1 motorway bridge, several hundred metres away (CA, 2011).
