# A Service Analysis of the Mont Blanc Tunnel Fire

**Abstract** *On 24th March 1999 a transport truck caught fire while driving through the Mont Blanc tunnel between Italy and France. Other vehicles travelling through the tunnel became trapped and fire crews were unable to reach the transport truck. The fire burned for 53 hours and reached temperatures of 1,000°C producing toxic smoke. Authorities compounded the problem by pumping air from the Italian side, feeding the fire and forcing poisonous black smoke through the length of the tunnel. A total of 39 people were killed. In the aftermath, major changes were made to the tunnel to improve its safety. This paper analyses the accident from a Services perspective, examining which critical services were in use (fire alert service, tunnel control service, ventilation service, etc), and which contributed in some way. The Safety Critical Systems Club (SCSC) Service Assurance Guidance v3.0 is used to guide the analysis and provide structure to the work, producing a service hierarchy map, criticality levels and identification of assurance needs. The improvements put in place after the accident are assessed to see the effect on the service

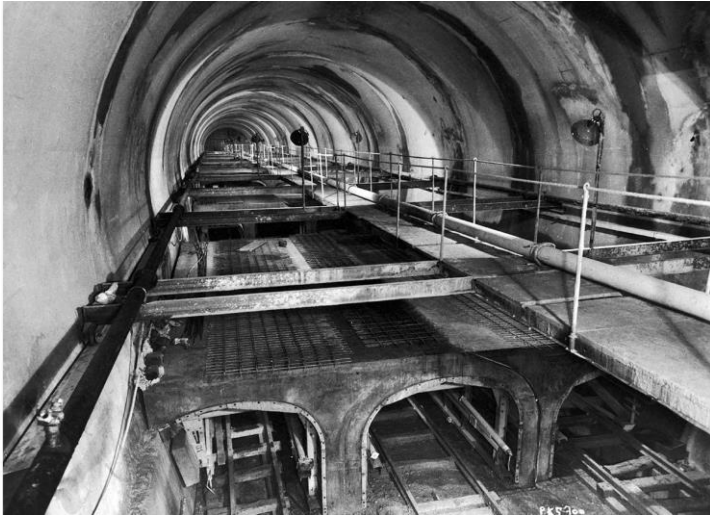
**Fig. 3.** Tunnel construction showing ducting under the roadway (GEIE-TMB, 2022)

Similar tunnels such as at Saint-Gothard and Fréjus have shafts intermittently positioned to provide ventilation. Mont Blanc does not, as this was considered impossible, meaning that to ensure adequate ventilation to dilute exhaust gases, fresh air could only be taken into the tunnel from either end, circulating through shafts under the roadway and distributed into the main tunnel through air vents spaced every 10m and located at the level of the road surface on one side of the road (Figure 3).

A separate duct located under the road surface is used to extract polluted air through vents positioned every 300m along the tunnel.

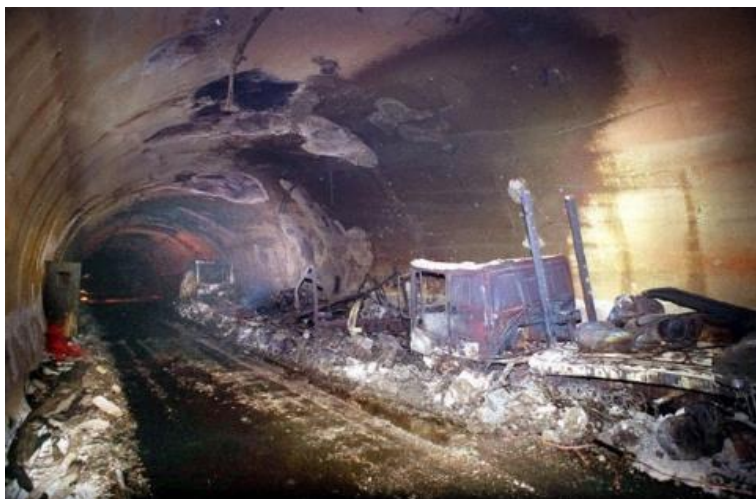
**Fig. 4.** Wreckage inside the Mont Blanc Tunnel (Bettelini, 2022)

The fire burned for 53 hours and reached temperatures of 1000°C with the extreme temperatures mainly due to the margarine on the trailer. It has been assessed that the trailer was equivalent to a 23,000-litre oil tanker. The fire spread to other cargo vehicles nearby that also carried combustible materials (Figure 4).

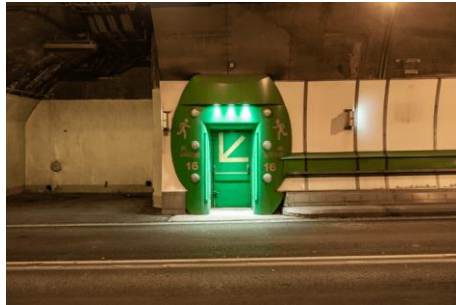
**Fig. 12.** Post-Fire emergency escape routes

Applying the guidance was able to highlight areas of concern in the service provision that should at least have prompted questions in the governing organisations who were accountable for those services. For example, users of the tunnel were not aware of the risks of remaining in their vehicles as opposed to seeking refuge in the available secure spaces. In the event of an incident the *Tunnel Operation service* should have been able to encourage users to vacate their vehicles and seek refuge. The problem, as Purser (2009) indicates, was that not only were there no such measures in place, but the refuges did not provide a means of escape to the outside and fresh air.
