# **Buncefield Incident – Some Lessons Learnt**

# Dr Fathi Tarada

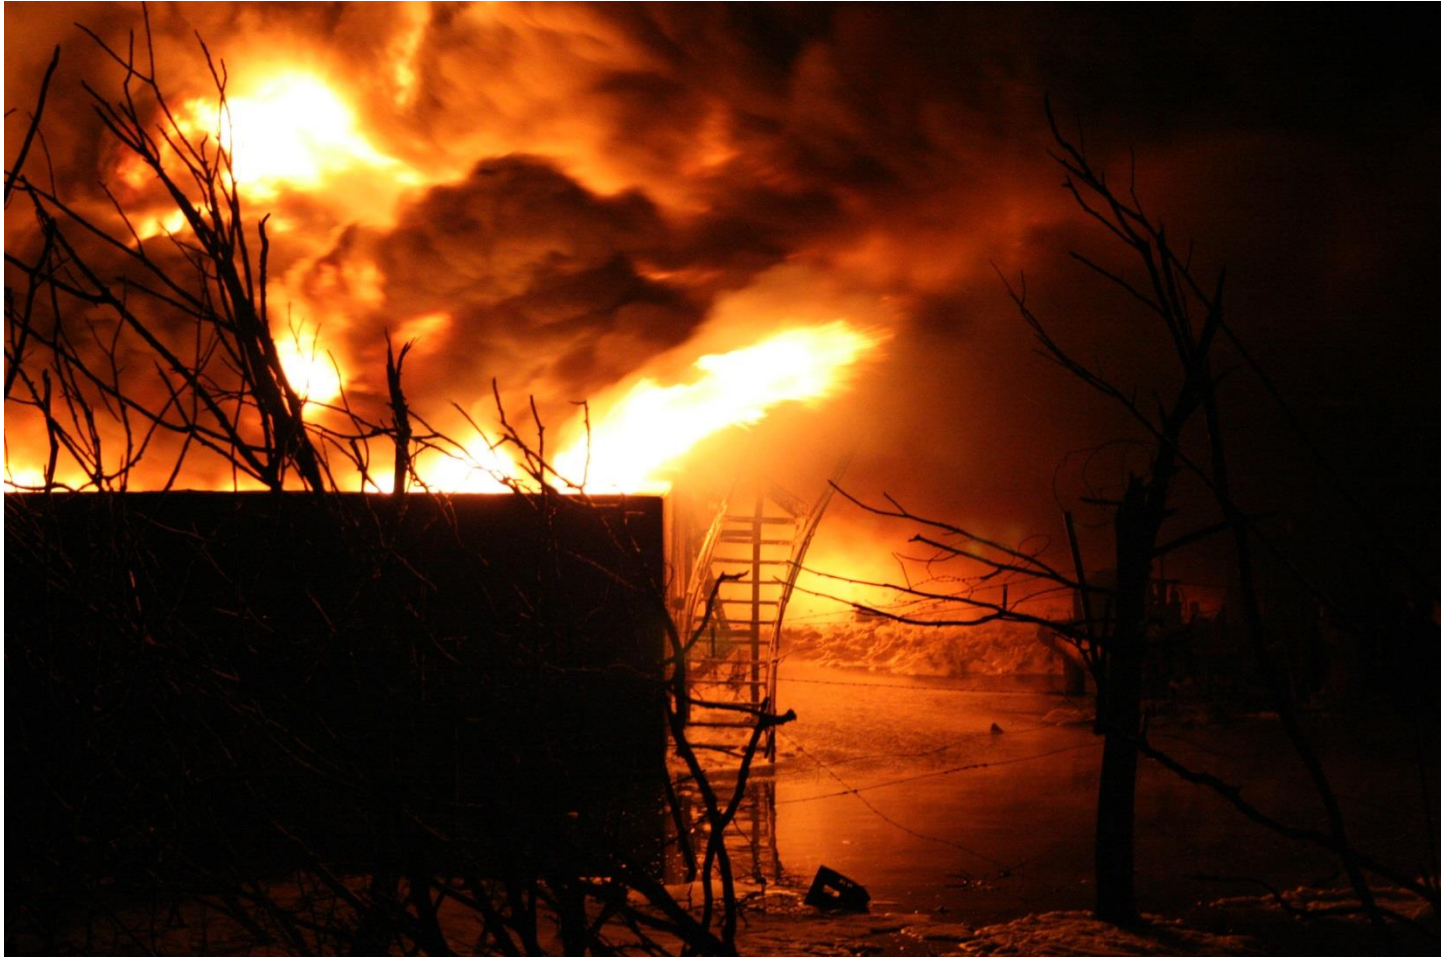
# Initial Fireball

- Large initial explosion from HOSL's tank T912, and consequent fire
- Fire spread over 22 fuel storage tanks and 7 bunds
- Six tanks on adjoining British Pipeline Agency Limited (BPA) site also involved in fire

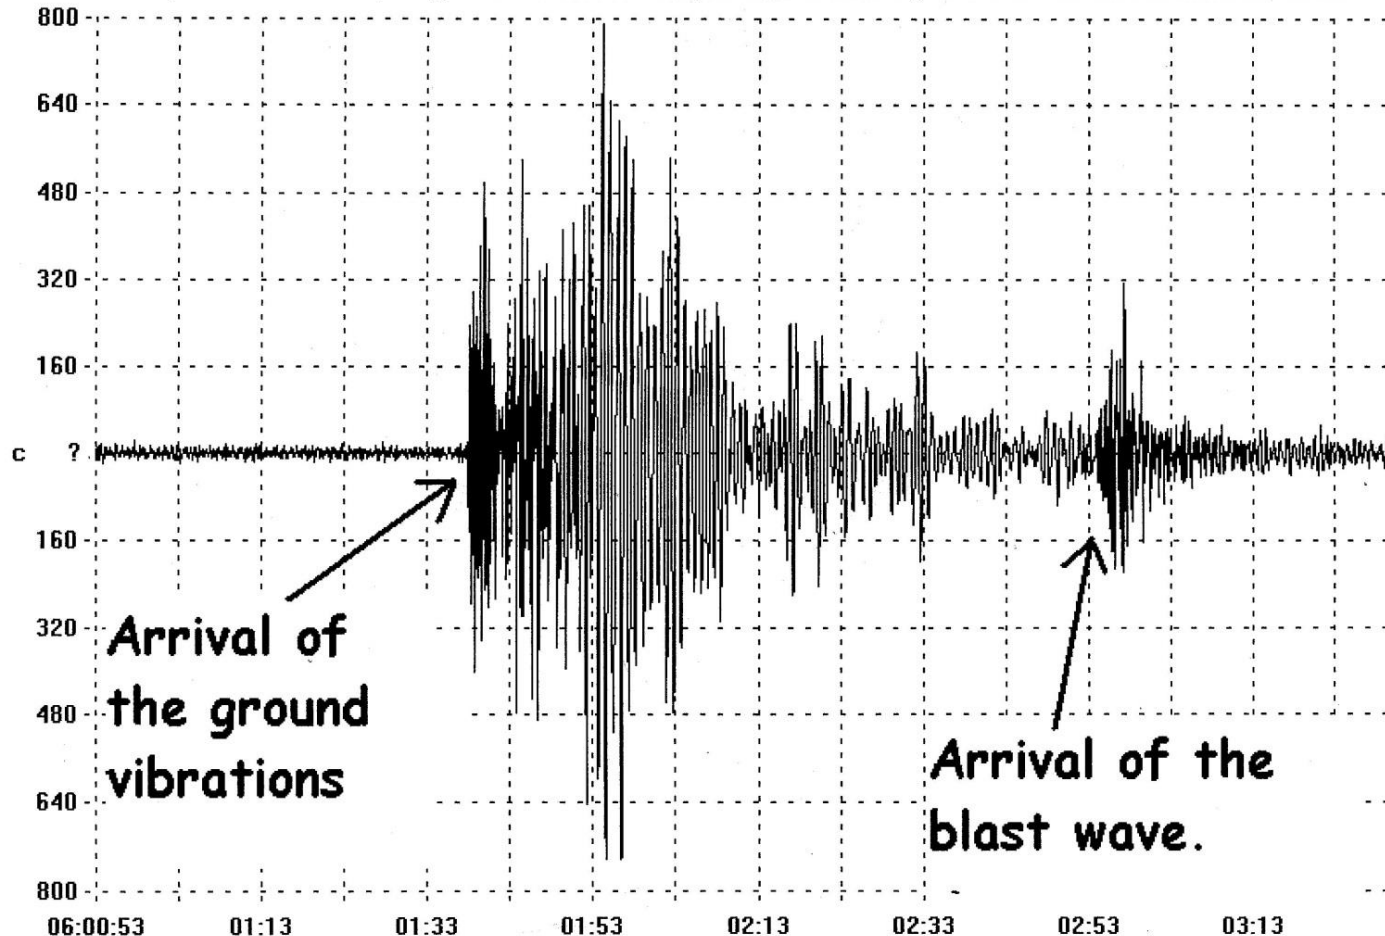
# Seismic Activity (Richter Scale 2.4)

Start: 12/11/05 6:00:52 UTC Station: HHUK 51.778N 0.0150000W Samples: 3161 SPS: 20  
Comment: 26km from HHUK. Max/Min: 787.4/-743.9 X: 2.37.0 Y: 800c  
Event Time: 12/11 06:01:31.0 Lat/Long: 51.772N 0.395W Depth: 0km 0.0mi Mag: Ms321.76 Mb0.59 Mw5.12 Md-27.28

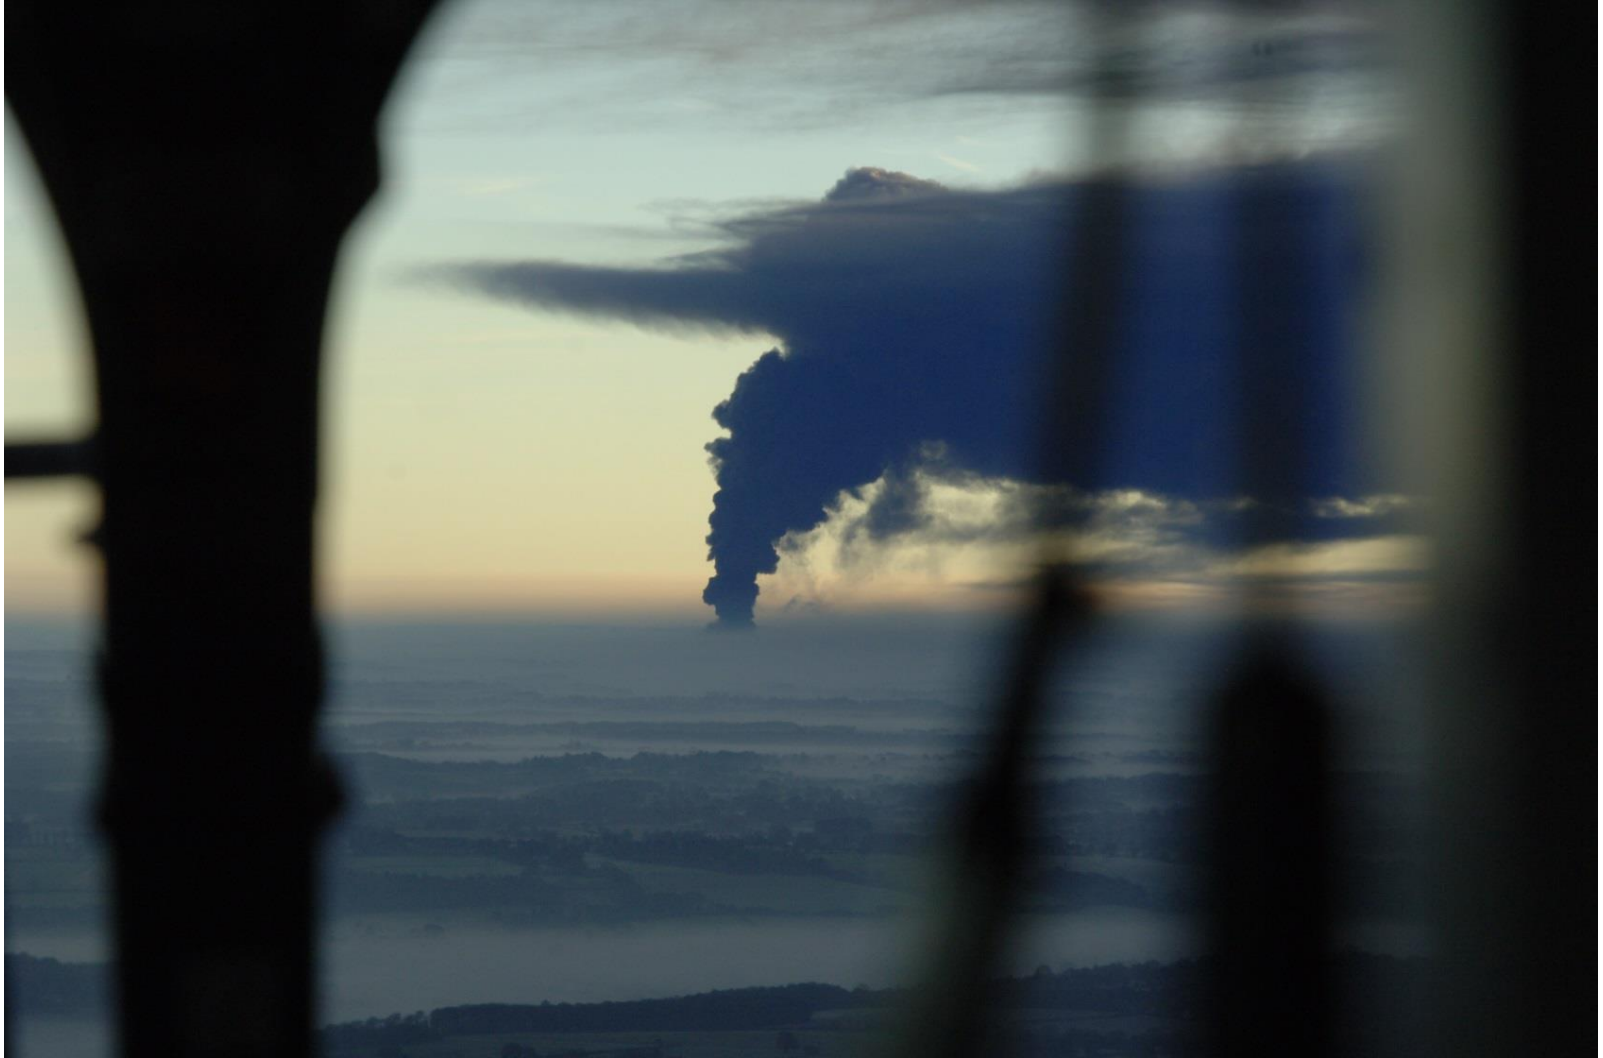
# Temperature Inversion

- Overflow of Tank 912 due to faulty gauge
- High-level switch also failed
- 300 tonnes of petrol spilled through tank's roof vents
- Vapour quickly flowed out of bunds and off the site, at 2m depth
- Unconfined vapour cloud explosion of unusually high strength

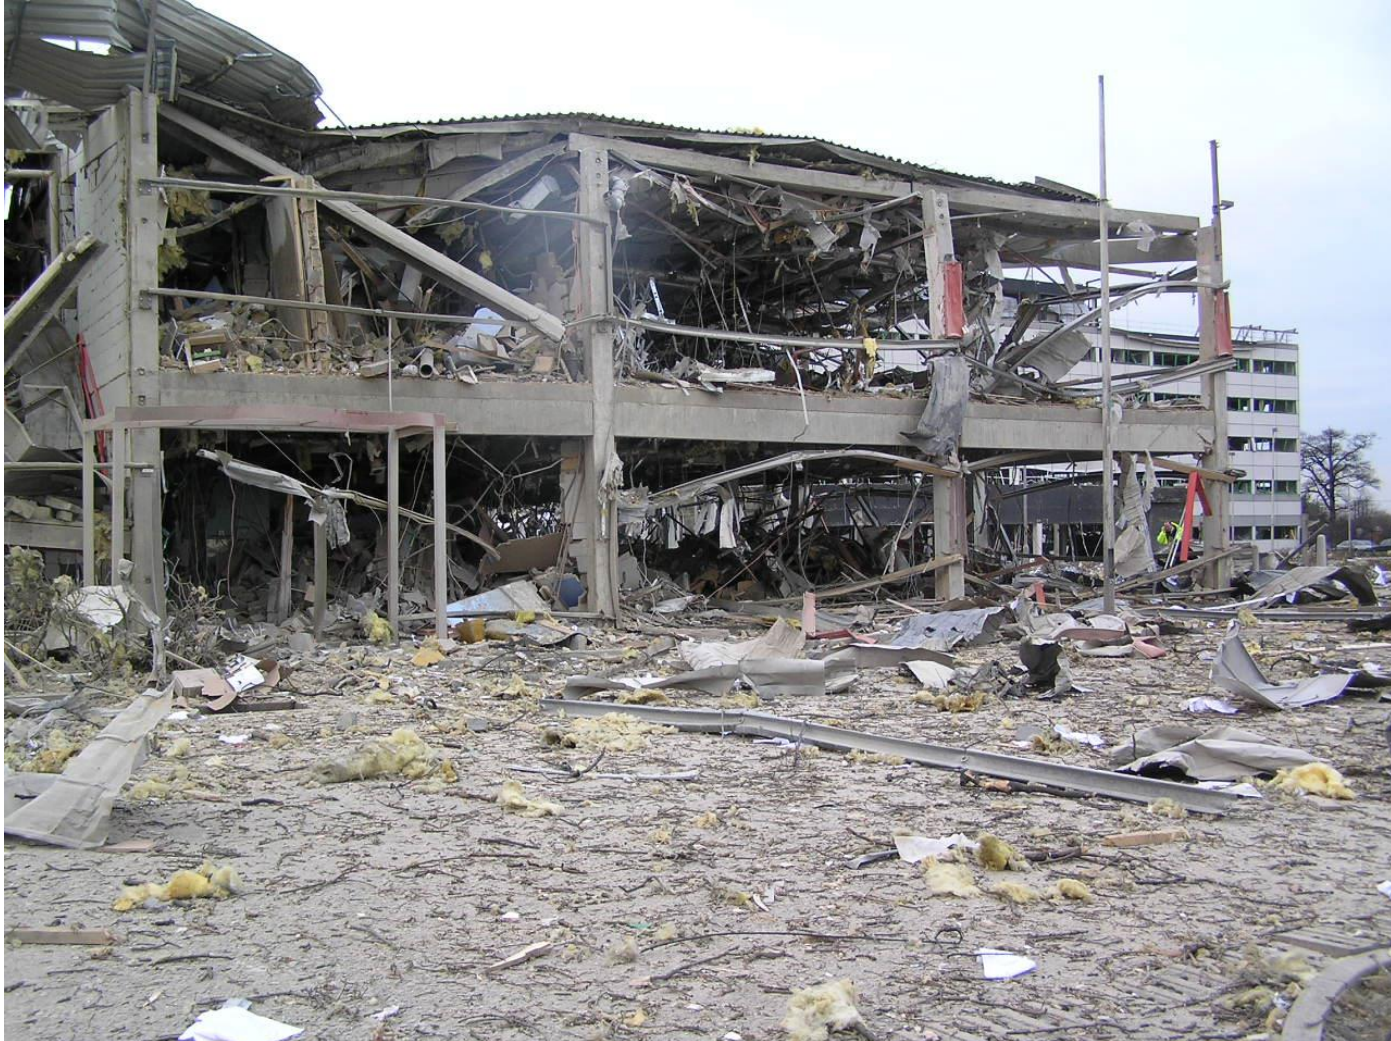
# Fuji Building

- Fire burned for 3 days
- 43 people injured (two hospitalised)
- Extensive property damage
