# Containment for petroleum products – lessons learnt from Buncefield, UK

**1 Fathi Tarada** BSc, DPhil, MBA, CEng, FIMechE, FIFireE, DipLLaw  
Managing Director, Mosen Ltd, Forest Row, UK

**2 Peter Robery** FEng, FICE, FCS, MICT  
Technology Director, International Transportation, CH2M HILL,  
Birmingham, UK

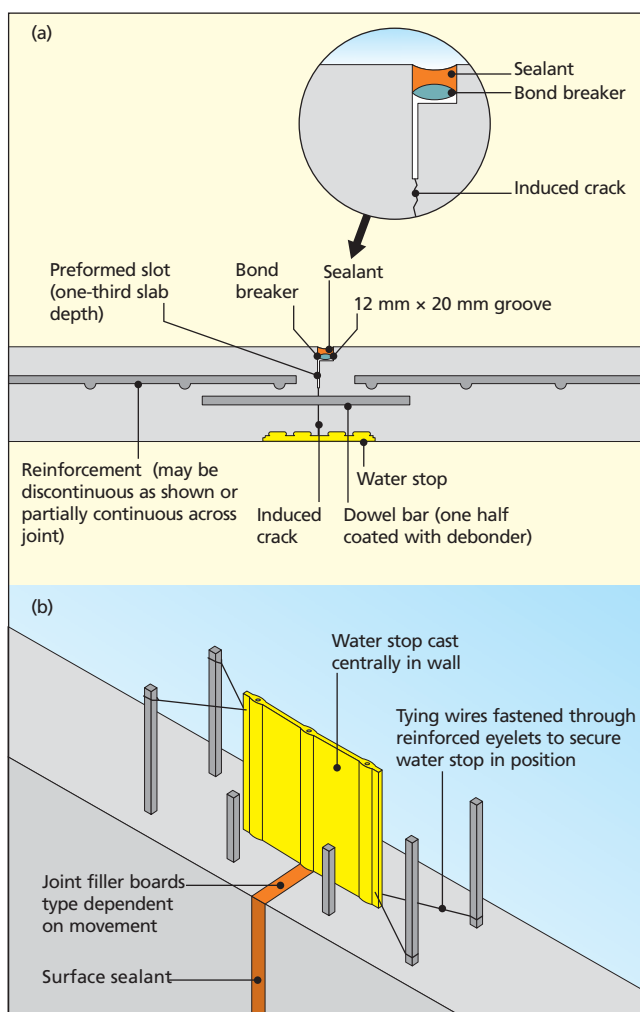
Figure 3. Movement joint details after Mason *et al.* (1997): (a) in a slab and (b) in a wall

The original bunds D and E had earth bases and concrete walls. The walls had PVC types of ‘dumb-bell’ water stops in the centre, similar to Figure 3(b), along with dowels. Metal plates had subsequently been installed over the joints on the inside surface of the walls during a refurbishment programme. The plates had over-sized holes to allow for movement when bolted into position and were sealed to the concrete surface with mastic. The plates appeared to protect the joints from the direct effects of radiation during the fire and no instances of melted PVC water stops or failed plates were found in the sections examined. Bunds D and E performed well in retaining products and firewater during the incident.

(CESWI; UKWIR, 1998) about polyvinyl chloride (PVC) and rubber water stops. With the potential for an incident involving burning fuels, the water stops may need to be fire resistant as well as resisting the fuels themselves and be capable of retaining firewater. As identified in Ciria C736 (Walton, 2014), hydrophilic water stops may be unsuitable as they are not designed to swell in the presence of petroleum fuels.
